Test Report

Report No. A225020563920102

Sample Name IP67 Fieldbus Series Products
Sample Received Date Apr. 2, 2025
Testing Period Apr. 2, 2025-Apr. 8, 2025

No.	Test Item
1	Mechanical shock test

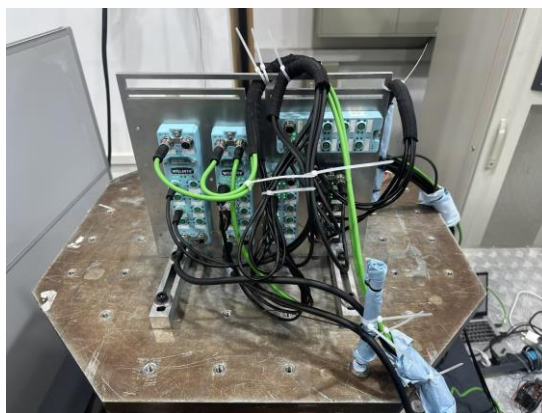
Sample No.	Judgment basis	Test result	Conclusion
A2250205639201002~009	There was no mechanical damage to the appearance of the sample after the test.	After testing, visually check the appearance of the sample without mechanical damage.	Pass
Remarks: The judgment basis is provided by the customer.

Test Photo(s)

Wave form	Acceleration(g)	Pulse duration (ms)	Test direction	Shock times
half sine	20	13	±Z	3time/direction
